Gamma Spectroscopy with Germanium Detectors

2015 REU Presentation - Tyler Takaro

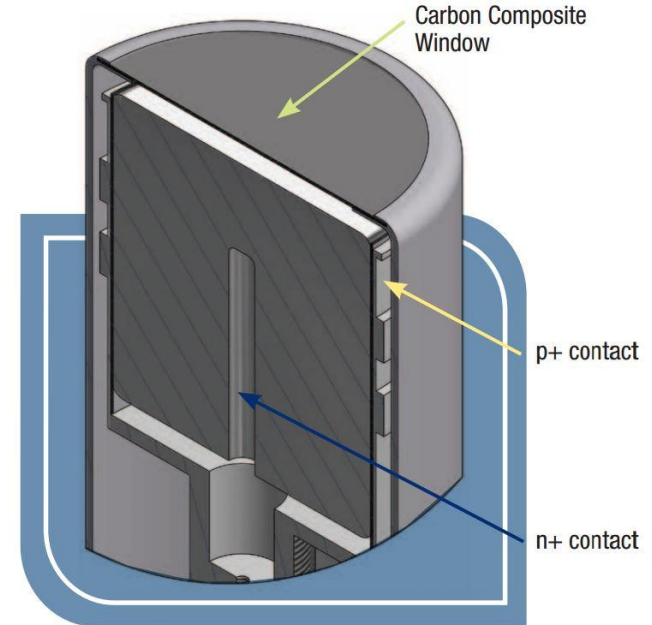
REGe Detector Configuration

- C1 is a reverse electrode coaxial Ge detector
- Detects secondary gamma particles from beta decay
- Radiation damage decreased
energy resolution: 2.6 keV \rightarrow 5.8 keV FWHM

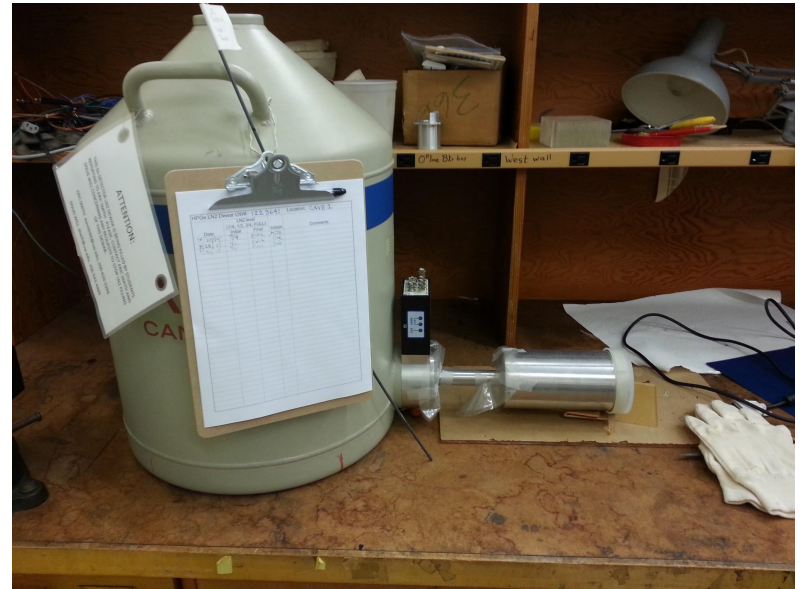
Image of C2, a similar detector to C1

- C1 previously had been having issues
- Initially saw microphonics when bringing C1 up to proper bias.
- Calibrated using 40K and background
 - Later calibrated using additional sources, and tuned for energy resolution

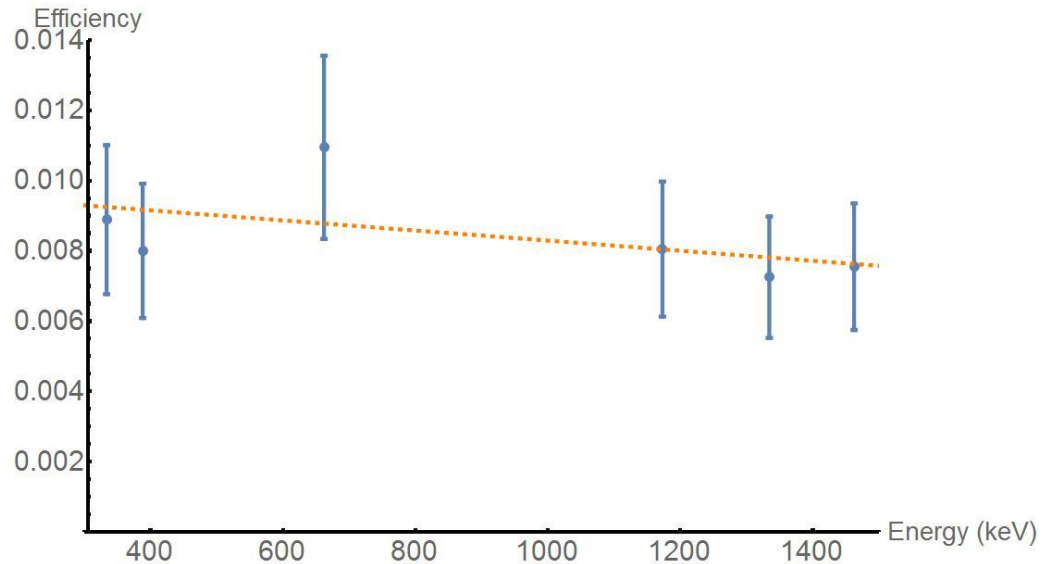
Efficiency of Detector

A series of radioactive sources with known activity were used to determine an efficiency for the detector as a function of energy.

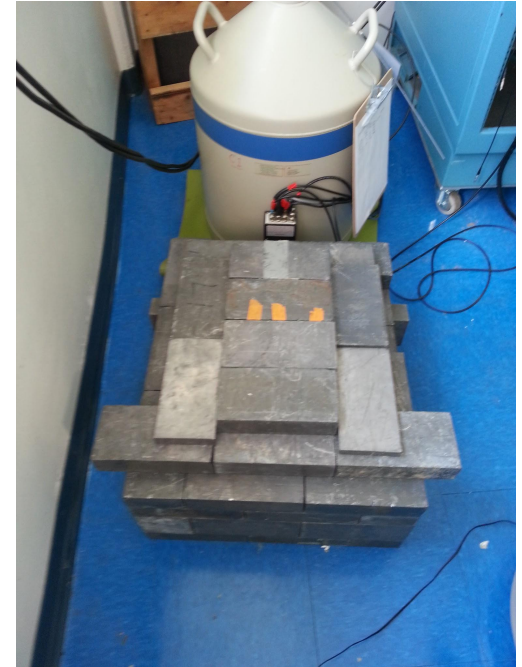
- Originally a single layer of lead was used, which caused a 90% decrease in the overall background count rate.
 - A N_2 flushing system was simultaneously built to remove radon in the air from adding to the background. This system had minimal effect and was discarded.
- Much later, a second layer of lead was added around the first to cover any gaps through which particles could fit. This further reduced the overall background rate by 25%, and the rate in ROIs for ^{208}Tl , ^{214}Bi , and ^{40}K 50%.

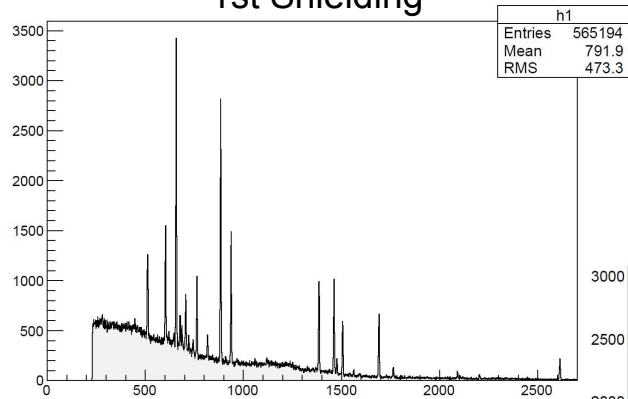
1st Shielding

Note that this run is only for 19 hours, rather than 24 like the others

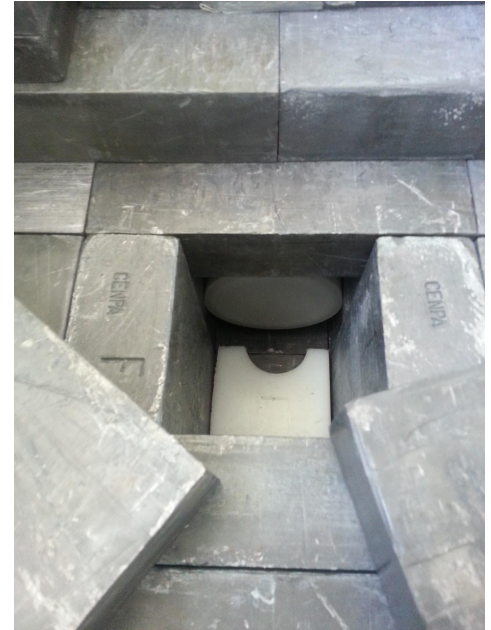
- The multilayered lead shield was found to have its most prominent background peaks in ^{110}Ag and ^{124}Sb . Lead is often alloyed with silver and tin. These stable elements could be converted to the unstable ones in the background through neutron capture.
- Due to other experiments in CENPA, it's quite possible that these lead bricks were bombarded by neutrons, making them active.
- The shielding was rebuilt with copper and 7 clean lead bricks. However, the copper was found to be quite active, so it was removed. The new shielding decreased the background by 50% for ^{110}Ag and 88% for ^{124}Sb .

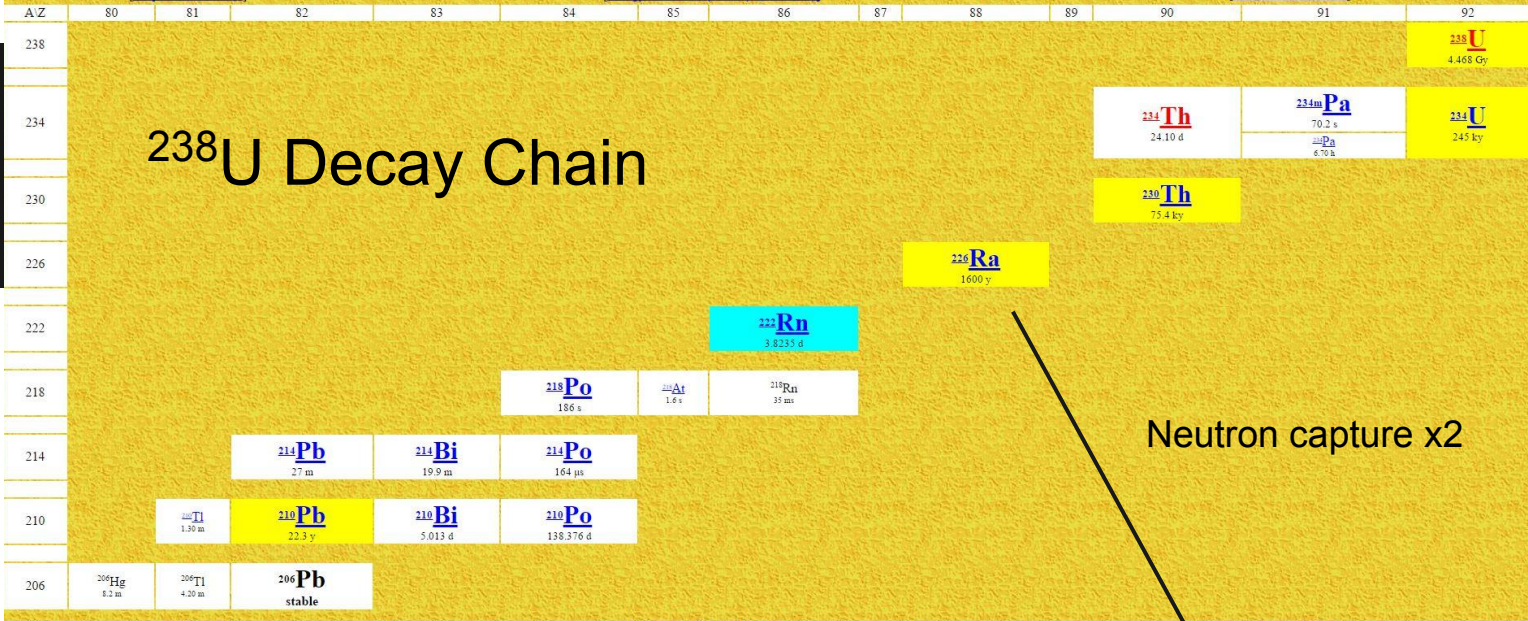
^{238}U Decay Chain

Neutron capture x2

- Originally believed to be depleted uranium. Lack of activity in ^{238}U decay chain proved this false.
- Tungsten source showed a higher ^{228}Ac activity than it did ^{208}Tl , despite both being generated by in the decay chain of ^{232}Th
 - Possibly due to consecutive neutron capture by ^{226}Ra to create excess ^{228}Ac , but more likely due to efficiency uncertainty
- ^{212}Pb activity also appears too high after adjusting for self-shielding, as shielding is highly dependent on photon energy.
 - No good theory to explain this
